# Manhole Inspection Summary

Manhole # S23II\_057MH

Insp Date: **10/1/07 9:59 AM**

**Location** Address: **630 BAKER ST**

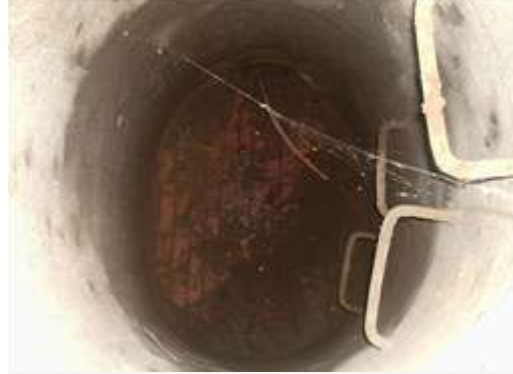
Top View

Corroded steps. Channel debris.

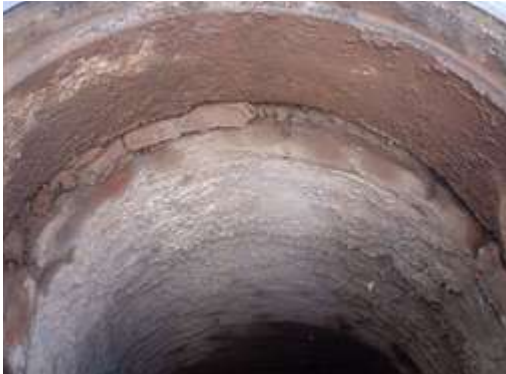
Defect

Frame leaks. Adjustment deterioration and infiltration. Barrel infiltration - other side.

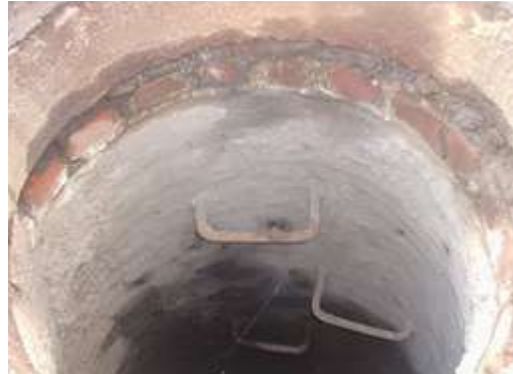
Defect

Frame leaks. Adjustment deterioration and infiltration. Barrel infiltration.

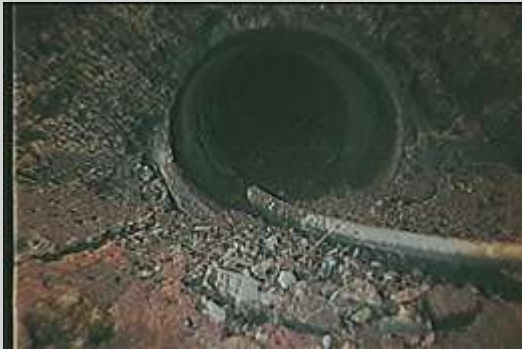
8 in. Circular Gravity Sewer  
Pipe Out @ 12 O'Clock

Deposits: ☐ None ☒ **Mud** ☐ Sludge ☒ **Debris** ☐ Grease

Silt Depth: **0.5** (in.) Deposits Extent: **Light**
